Assessment – Post-Trip Report

Executive Summary	
Community:	Los Churuneles II
Country:	Guatemala
Chapter:	Kansas City Professional Chapter
Submittal Date:	10/20/2019
Authors:	Jake Sanders, Josh Hester, Helen Wehner, Jillian Gallagher, and Abe Fangman
REIC and other mentors:	Scott Struck, PhD (REIC), Stephen Collins (professional mentor)
Scope of Work for the project (50 words) ¹	Design and implement modifications to an existing water supply system in a town of 480. Project potentially includes installation of water transmission piping, a water storage tank, water distribution piping and a water treatment system.
Scope of Work for the trip (100 words) ²	This was the first assessment trip where: 1) initial design concepts were presented to the community for input, 2) final survey data was collected and the project site was investigated, this included the sources intake site, the proposed storage tank location and community geography for distribution planning and 3) land agreements were discussed.

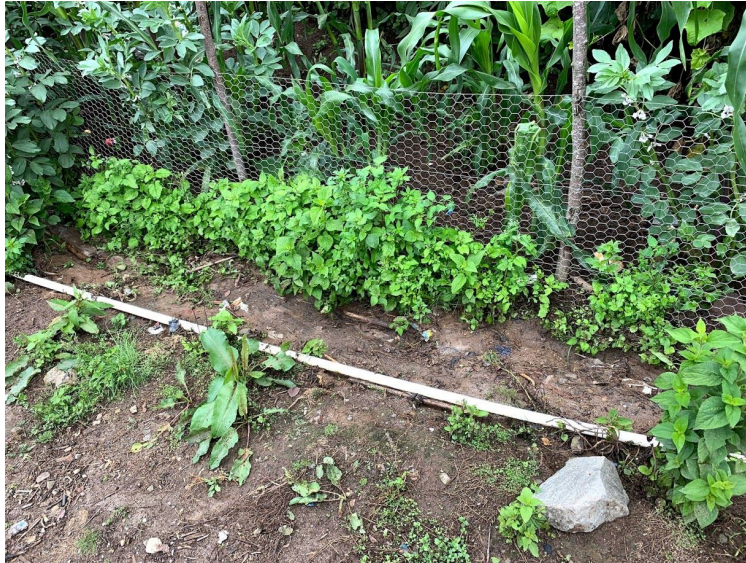
Photo 1: Existing water distribution system exposed near the main road running through the community.

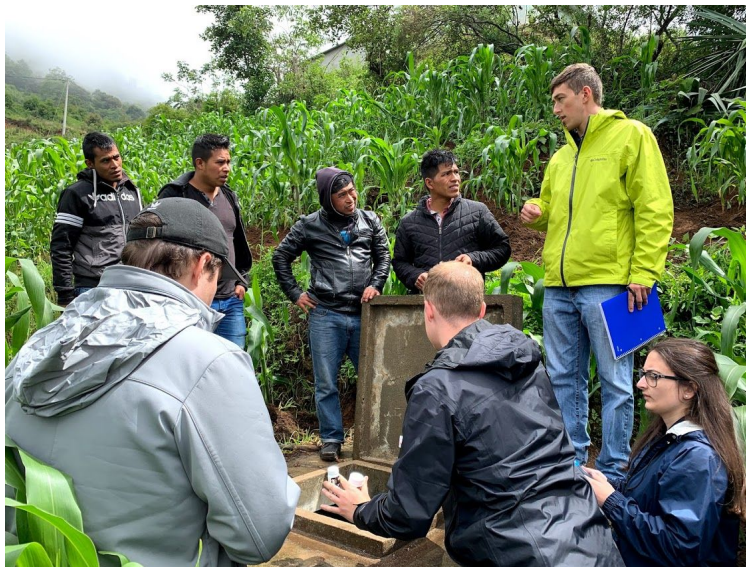
Photo 2: Members of COCODE and the EWB-KC travel team taking water samples at the existing storage tank in a corn field in the community.

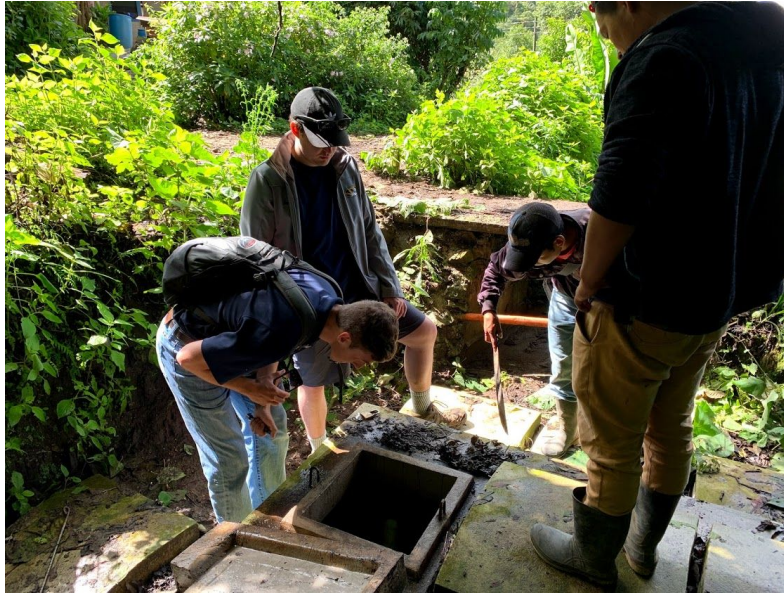
Photo 3: Members of COCODE and EWB-KC evaluating the structure that divides water flow from the source between Los Churuneles II and two other nearby communities.

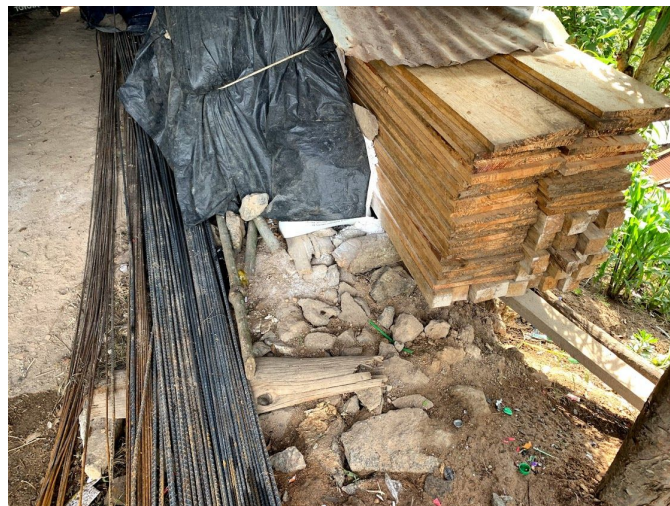
Photo 6: Rebar and wood framing used in the construction of a new house in the community.

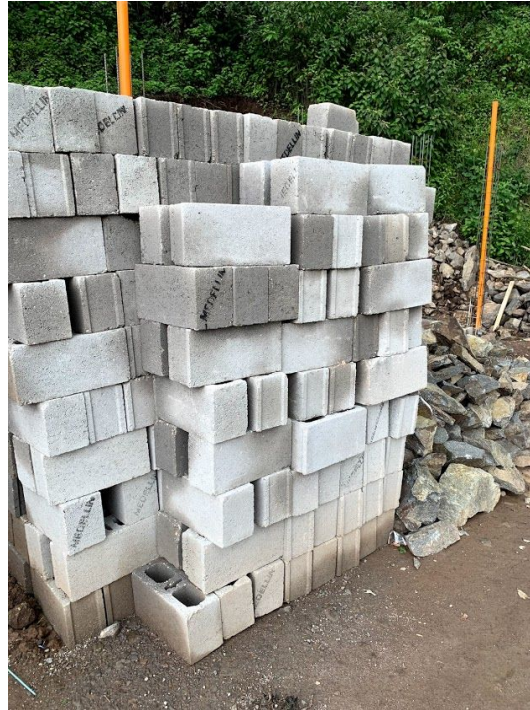
Photo 7: CMU used in the construction of residential house.
